Debris/Ice/TPS Assessment and Integrated Photographic Analysis of Shuttle mission STS-102

Technical Memorandum – 2001 – 210257

May 2001

**DEBRIS/ICE/TPS ASSESSMENT
AND
INTEGRATED PHOTOGRAPHIC ANALYSIS
OF
SHUTTLE MISSION STS-102**

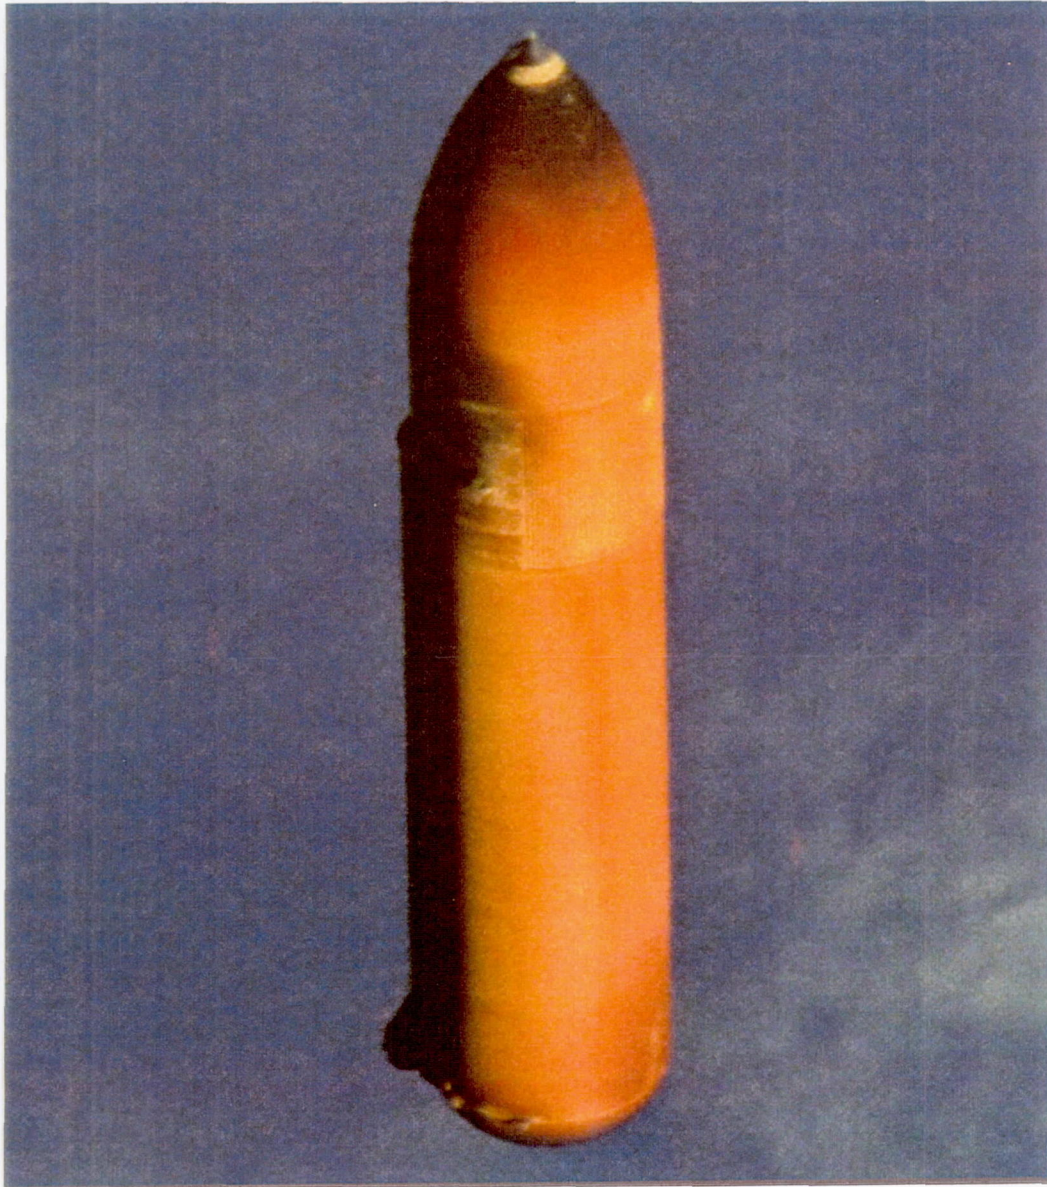
Photo 11: Astronaut Handheld Camera View of the External Tank

No anomalous condition were noticed

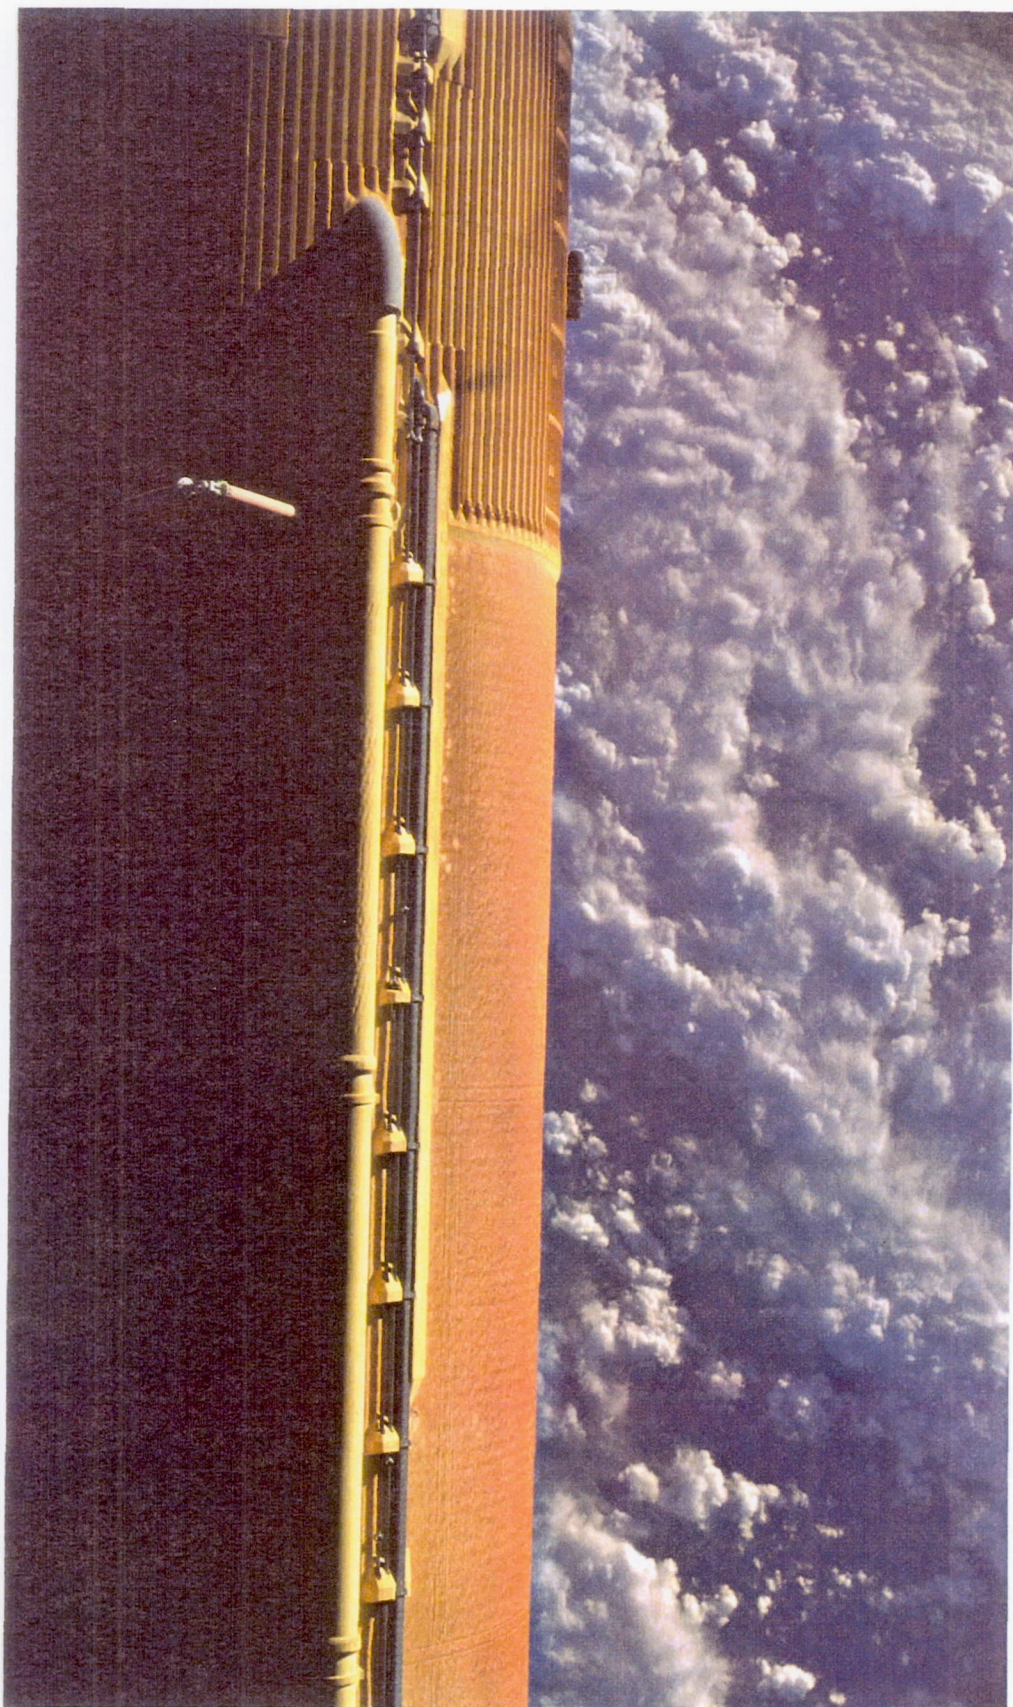
Photo 13: View of the External Tank after sep
No anomalous condition was noticed.

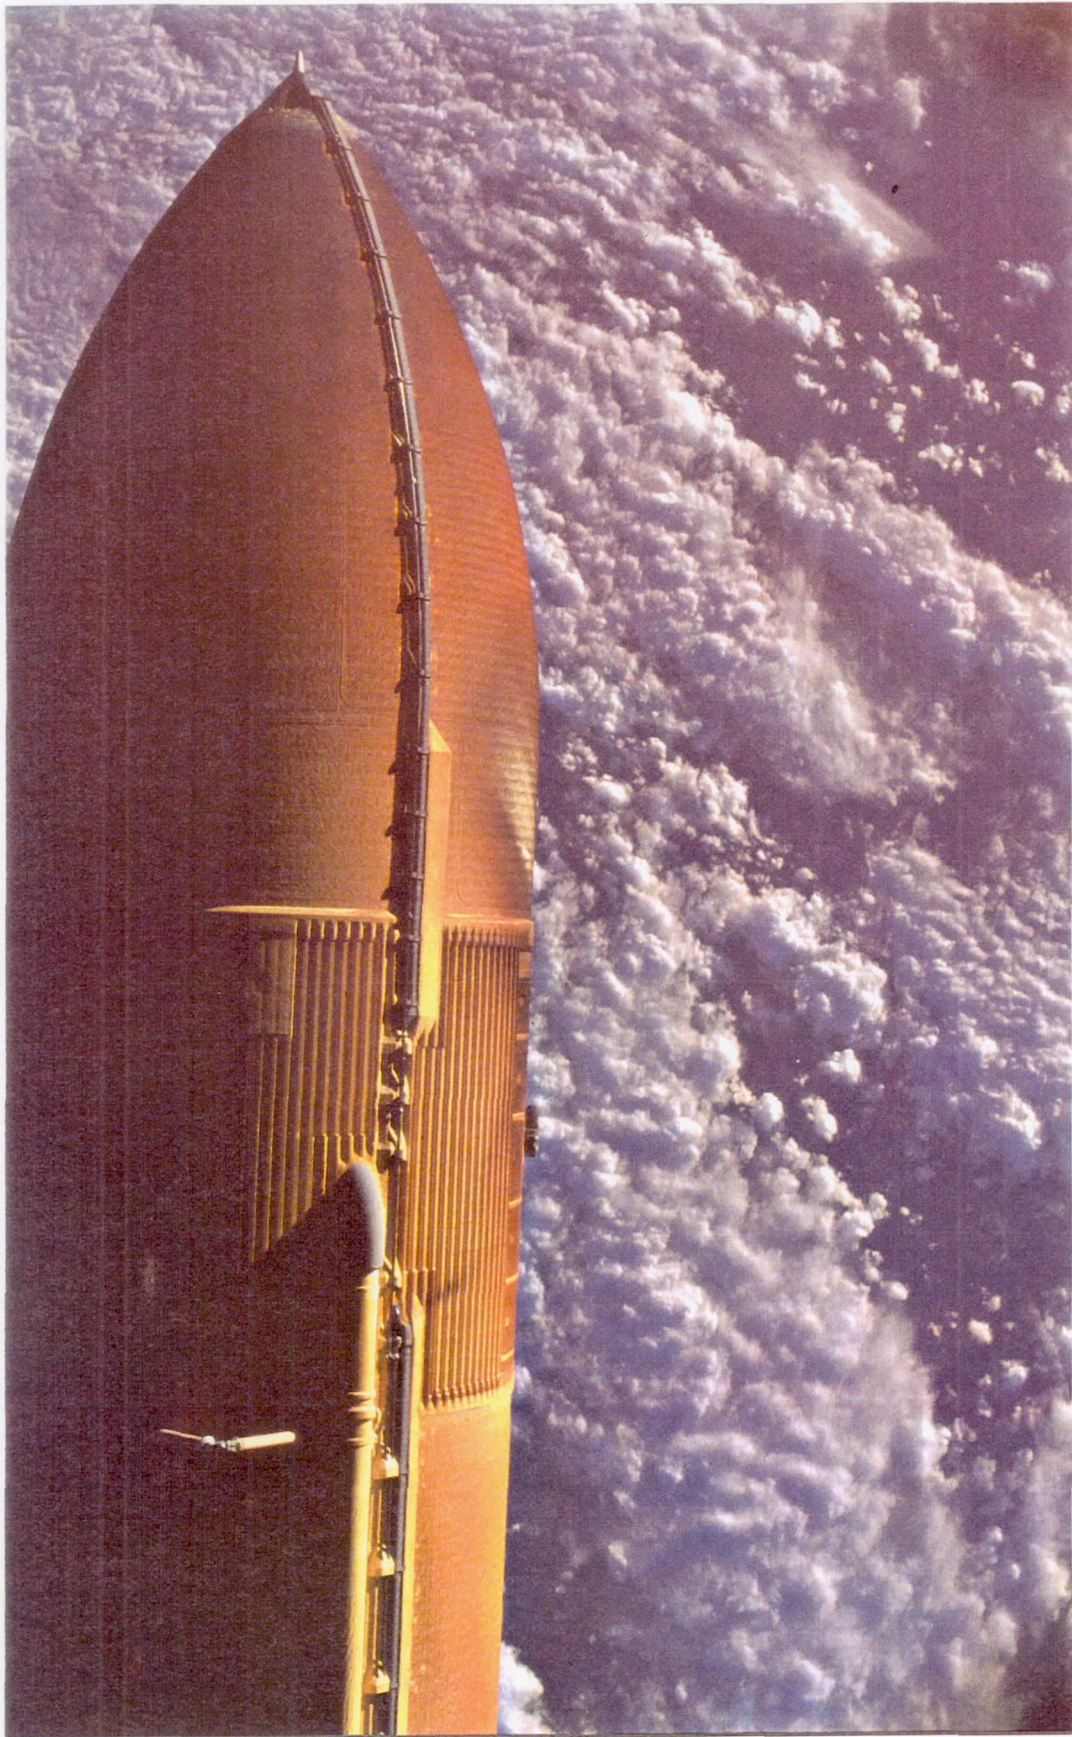
Photo 14: View of the External Tank after sep
No anomalous condition was noticed

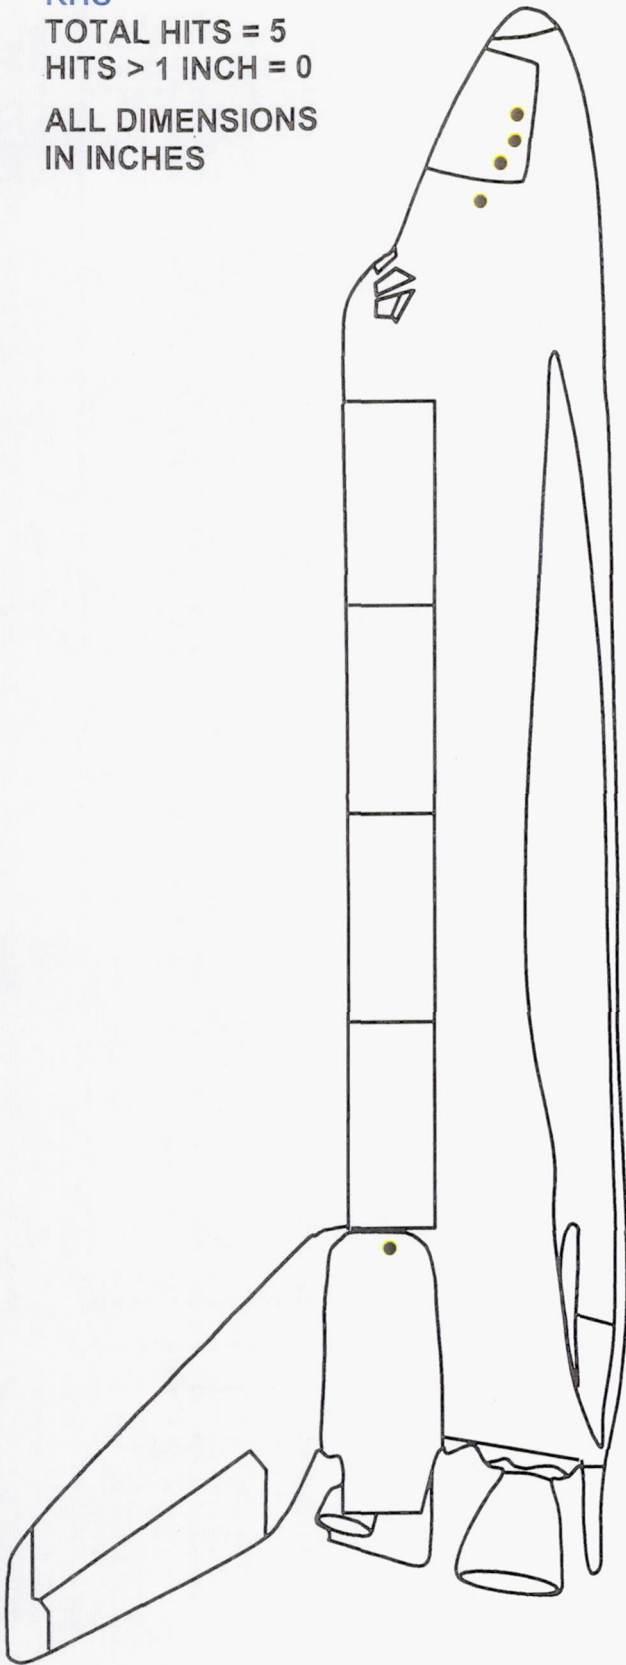
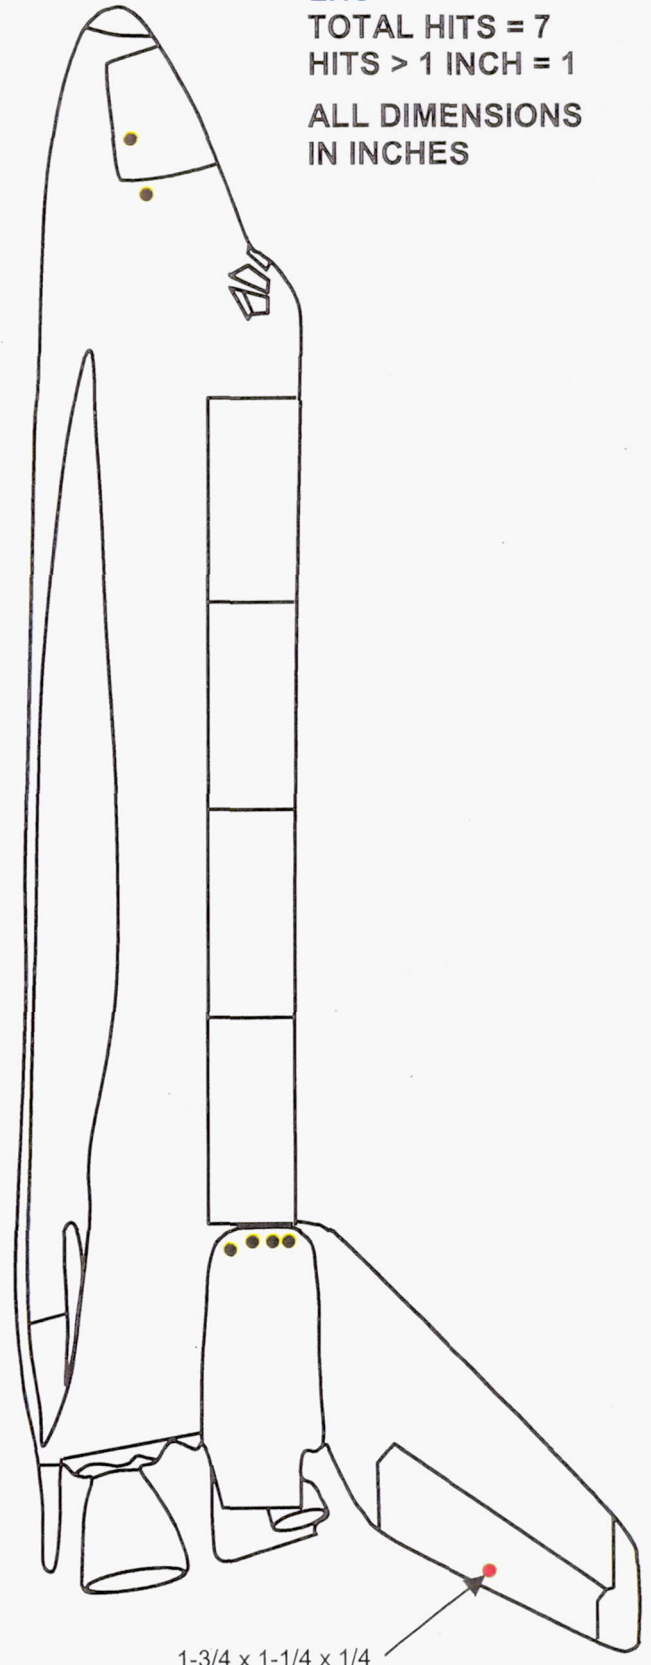
Figure 3: Orbiter Right/Left Sides Debris Damage Map

TOTAL HITS = 7

HITS > 1 INCH = 1

1-3/4 x 1-1/4 x 1/4

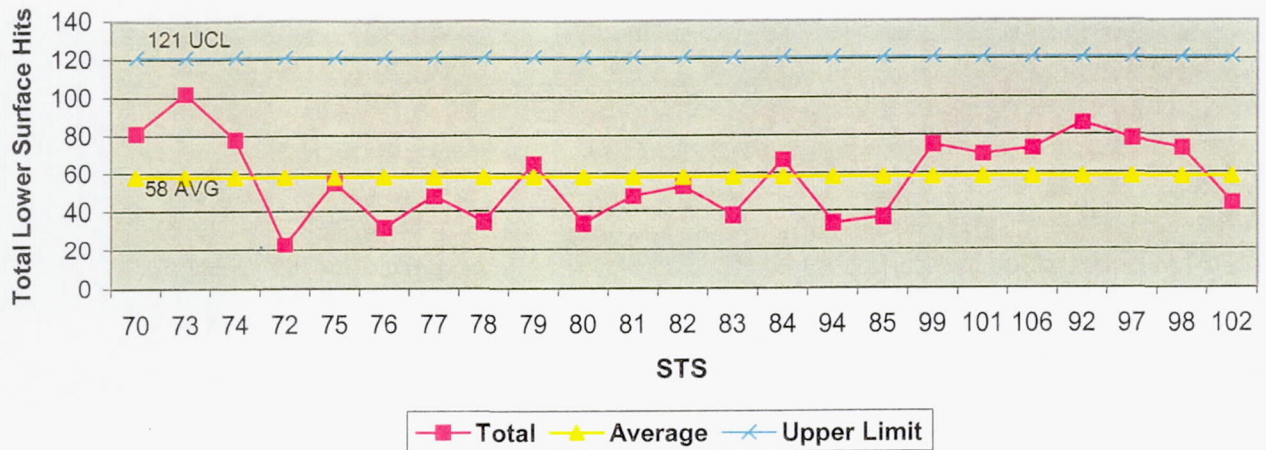
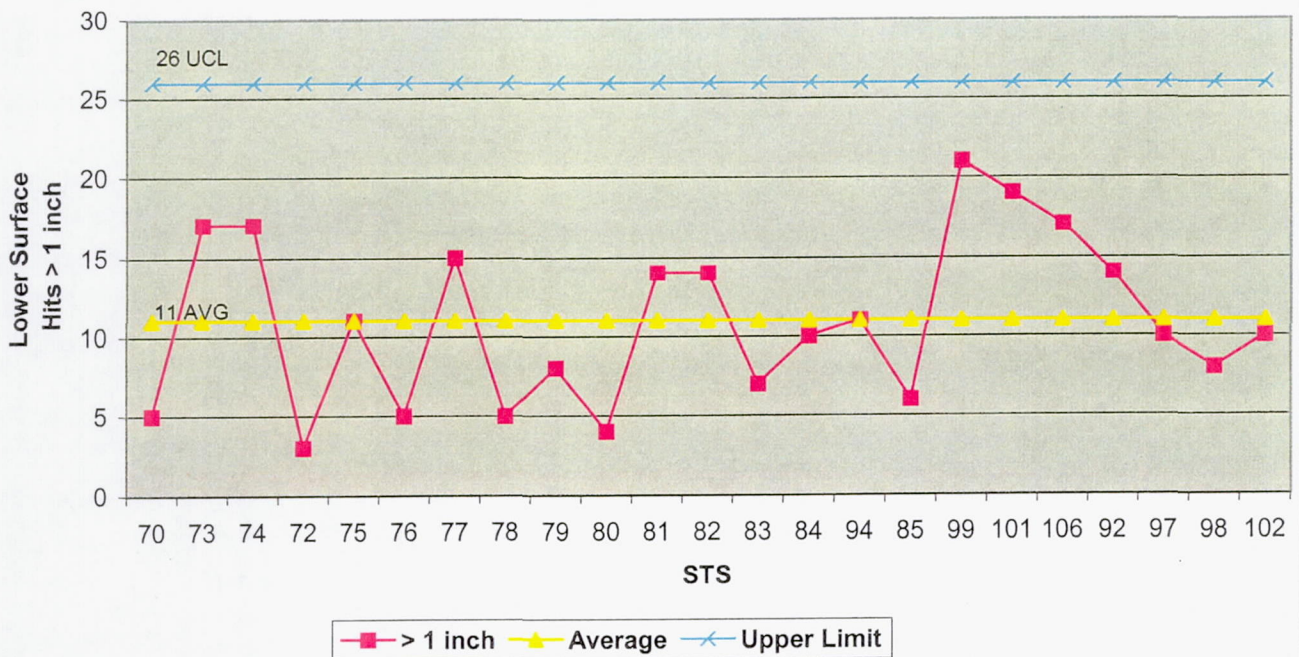
Figure 4: Orbiter Post Flight Debris Damage Summary

In summary, both the total number of Orbiter TPS debris hits and the number of hits 1-inch or larger were well within established family (reference Figures 3, 4 and 5).

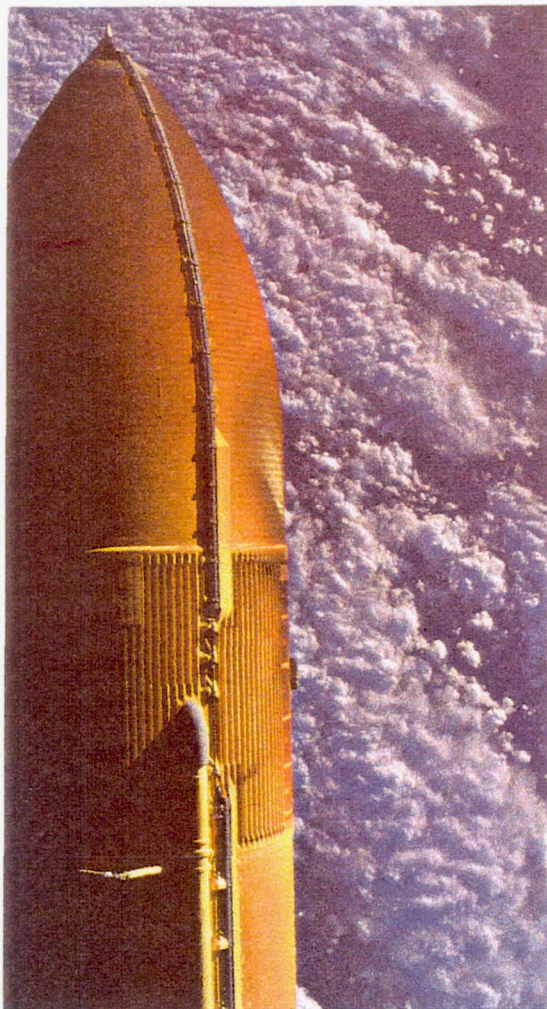
Figure 3.2.3 (C) 35mm Umbilical Well Camera View of Forward ET

The LO2 tank / Ojive TPS appeared to be in excellent condition. The nose of the ET appeared free of damage and the nose cap appeared in good condition. The aero friction and aero heating marks seen on the TPS just aft of the nose cone appeared normal and were less than that typically seen on previous missions.

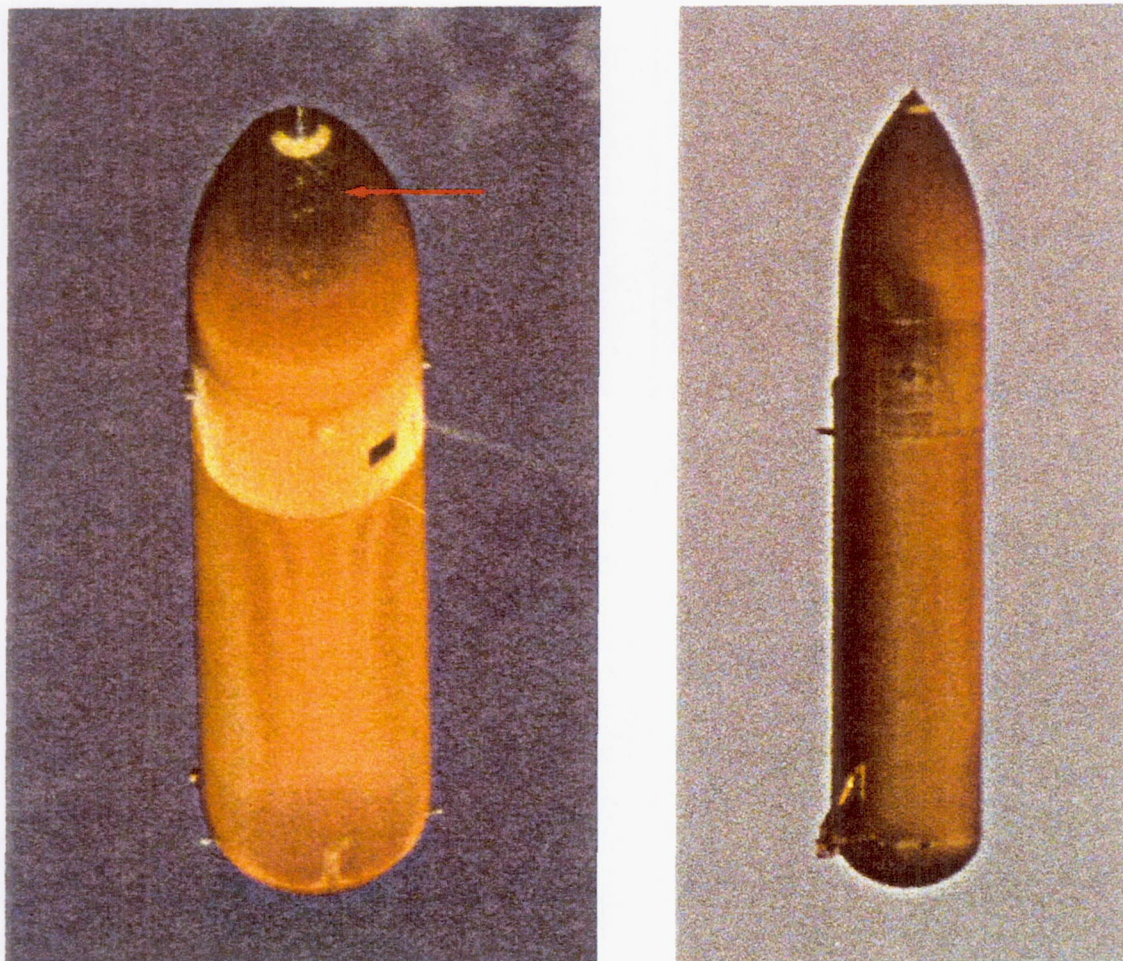
Figure 2.3.3 Crew Handheld Images of the External Tank

The normal SRB separation burn scars and aero-heating marks were noted on the intertank and nose TPS of the ET. The LO₂ tank / Ojive TPS appeared to be in good condition. However, there were several light-tone marks on the -Z side of the nose that appeared to be ablated TPS. See Figure 2.3.3, Crew Handheld Images of the External Tank (arrow).

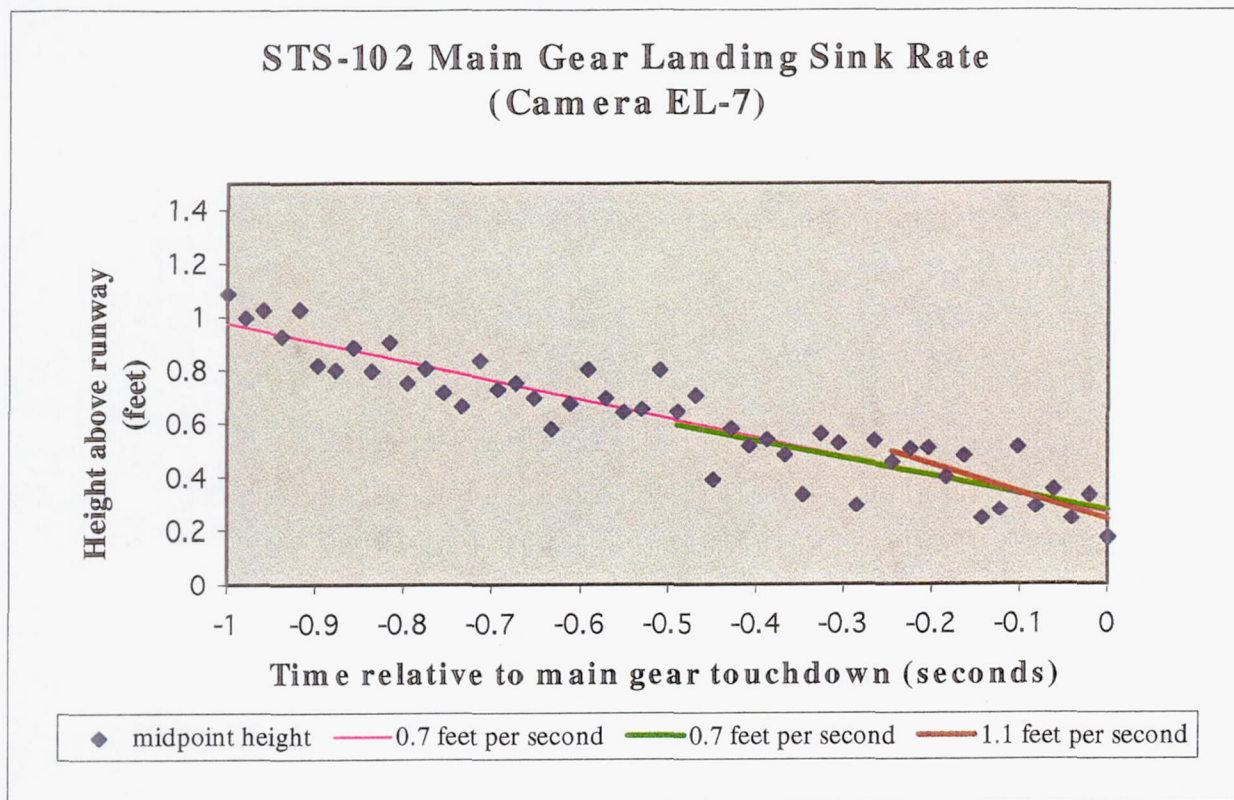
Figure 2.5 Main Gear Midpoint Landing Sink Rate

The main gear sink rate for STS-102 landing at one second, at half a second, and at a one quarter of a second are provided in Table 2.5. The left main gear sink rate and the midpoint between the main gear are relative to left main gear touch down. A plot describing the sink rate for the midpoint between the main gears is shown in Figure 2.5.

The maximum allowable main gear sink rate values are 9.6 feet / second for a 212,000 lb. vehicle and 6.0 feet/second for a 240,000 lb. vehicle. The landing weight of the STS-102 vehicle was reported to be 218,304 lbs.
